## THE ADDED VALUE OF A MULTIDISCIPLINARY APPROACH FOR THE CHARACTERIZATION OF A COMPLEX SITE

REMTECH EUROPE CONFERENCE

September 18<sup>th</sup>, 2019

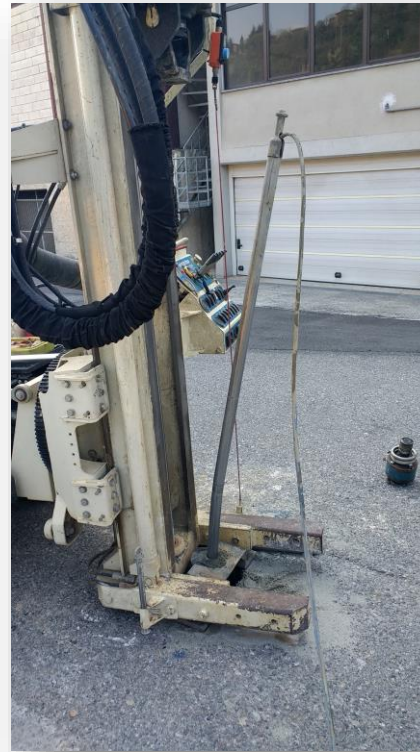
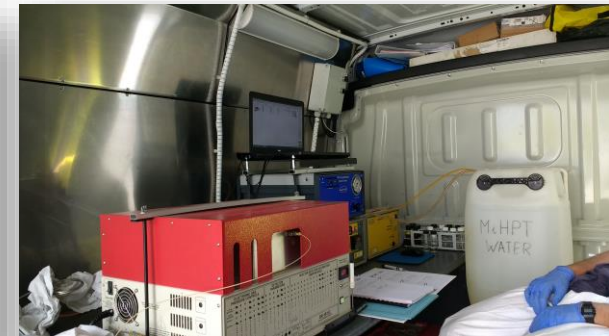
# Membrane Interface Probe + Hydraulic Profiling Tool

- MiHPT (21 investigation points), using GeoProbe

## → Spatial variability in the bedrock elevation:

- deepening along the west-east direction (0,5 - 11 m b.g.l.)
- irregularity and presence of local depressions

## → Presence of **VOCs** and **Hydrocarbons**

## → Identification of potential **historical source of contamination** (buried concrete basin formerly used for degreasing activities)

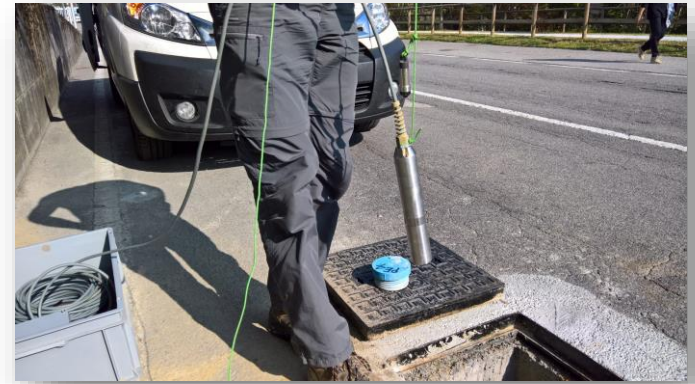
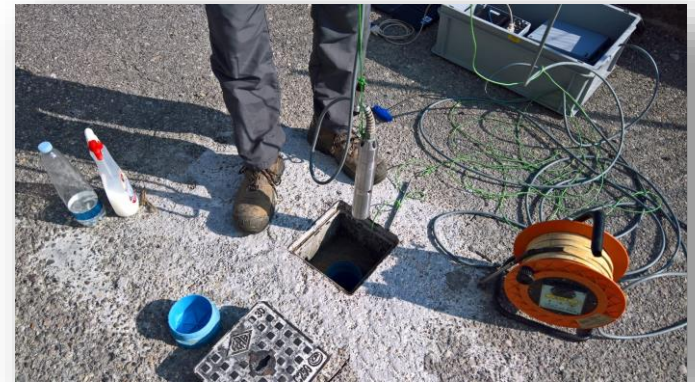
# Hydraulic testing

- Step drawdown tests
  - Constant rate tests
- No stabilization during SDT even at low flow (2 – 12 l/min) → **poor productivity and slow recharge**
- Calculation of the aquifer **transmissivity and permeability** to support remedial design

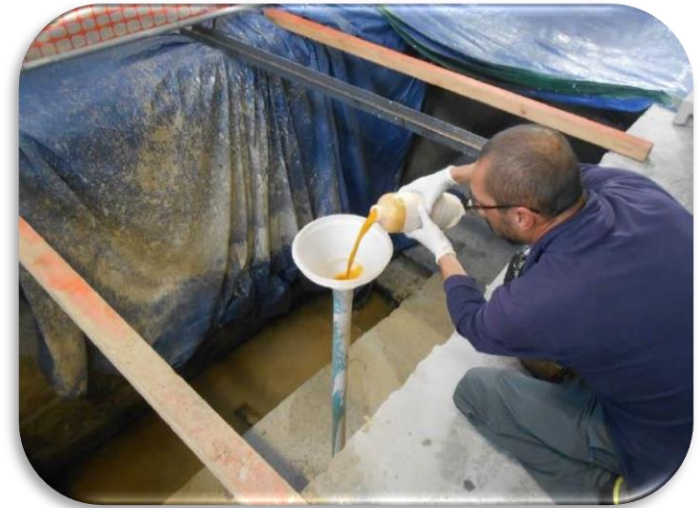
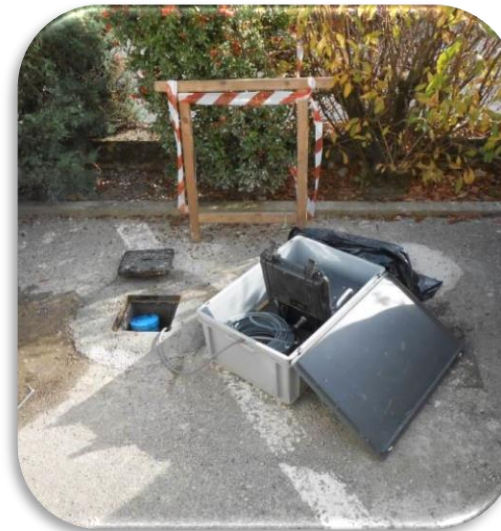
# Tracer test

Injection (sodium fluorescein) at historical source of contamination

- **Tracer detected side-gradient of injection point** → confirmed that aquifer responds almost instantaneously to precipitation event; confirm radial pattern with a predominant southern direction, consistent with the bedrock profile
- Estimate of **groundwater flow velocity** → indicates that the flow occurs primarily via surficial deposits, with no evidence of fractured portion of the bedrock

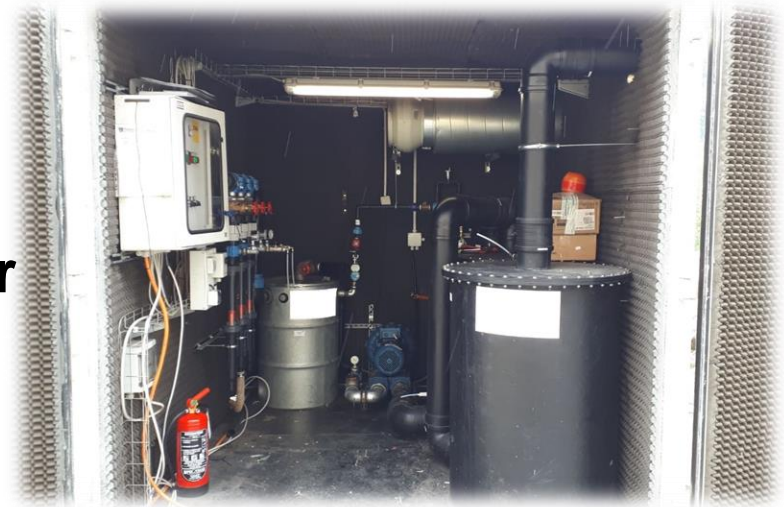
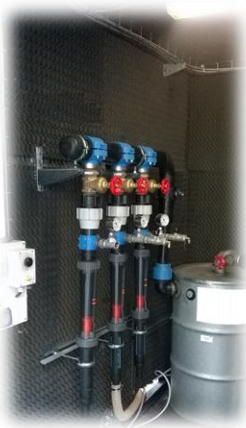
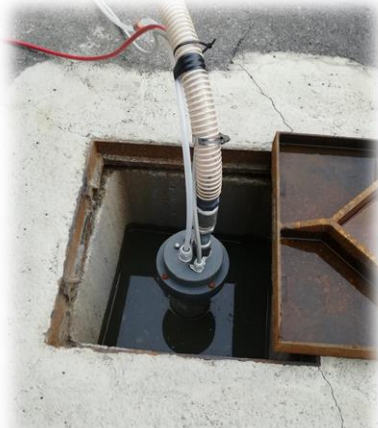
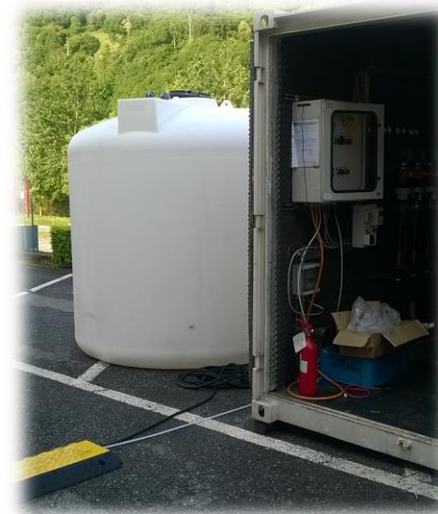
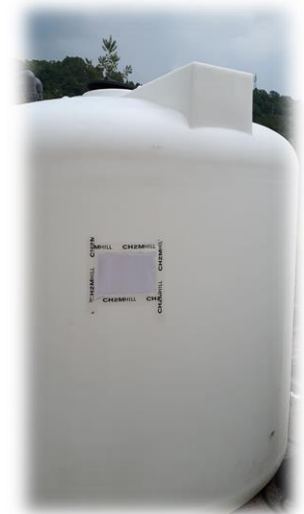
# Dual Phase Extraction (DPE) – Pilot Test

1. **Feasibility of DPE** as hydraulic control system
2. Confirmation of **ephemeral recharge system** of the aquifer
3. **Logging of additional hydrogeological parameters**, useful for DPE Full Scale design (radius of influence...)

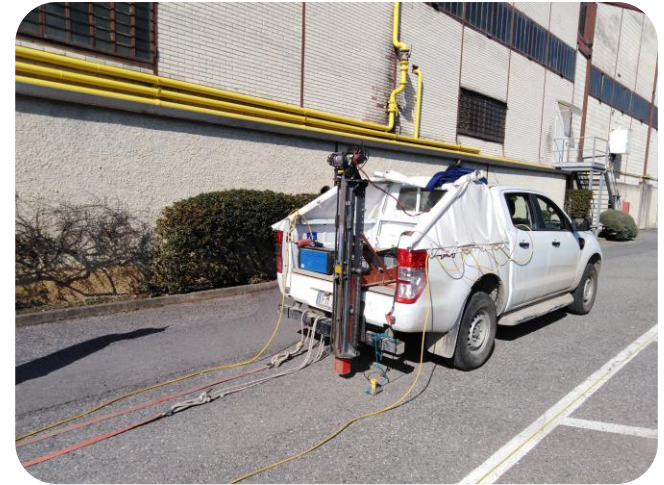
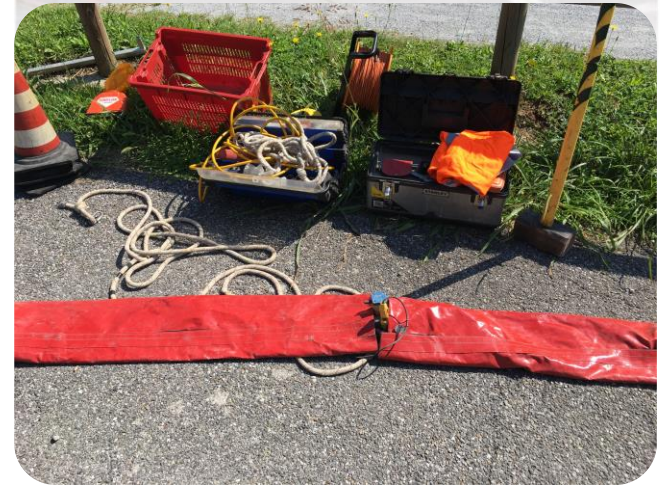
On-board seismograph  
(DATA RECORDING)

Source of energy  
(accelerated mass)

String of geophones on  
land streamer

The streamer is dragged at low speed,  
stationing every meter

- 1<sup>st</sup> survey along East border of the Site, to **support design of DPE Full Scale** (hydraulic control)
- 2<sup>nd</sup> seismic survey downgradient of potential primary source of contamination, to **support installation of additional MW**

→ Detailed mapping of the bedrock profile

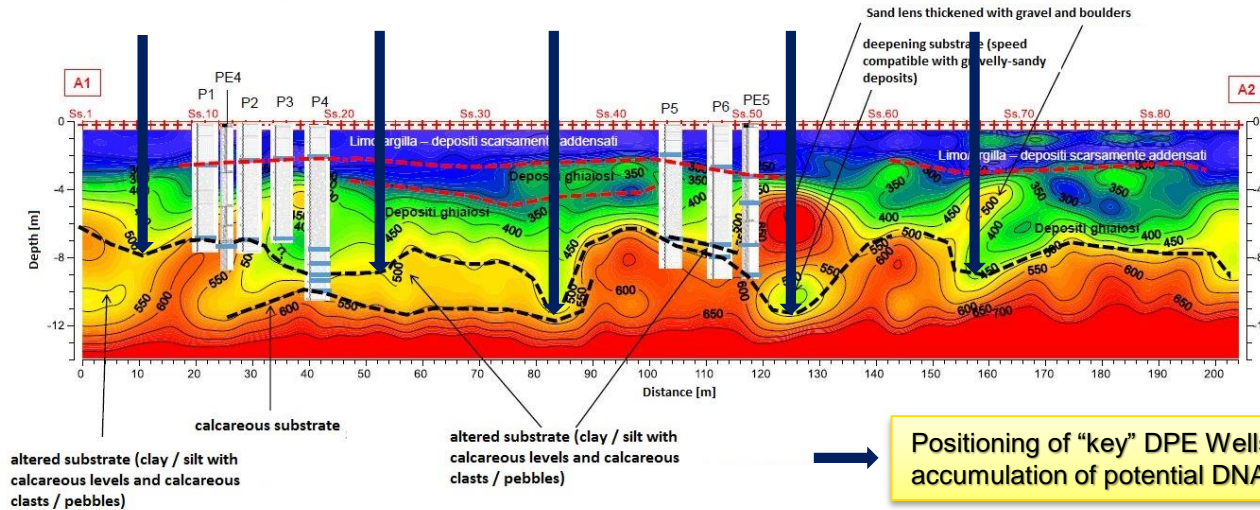
2D MASW SEISMIC SECTION - SPEED MODEL OF CUTTING WAVES (Vs)

2D MASW Seismic section 1 (170 m)
